EMERGENCY ACTION PLAN

Federal Marine Terminal Riverview, Michigan

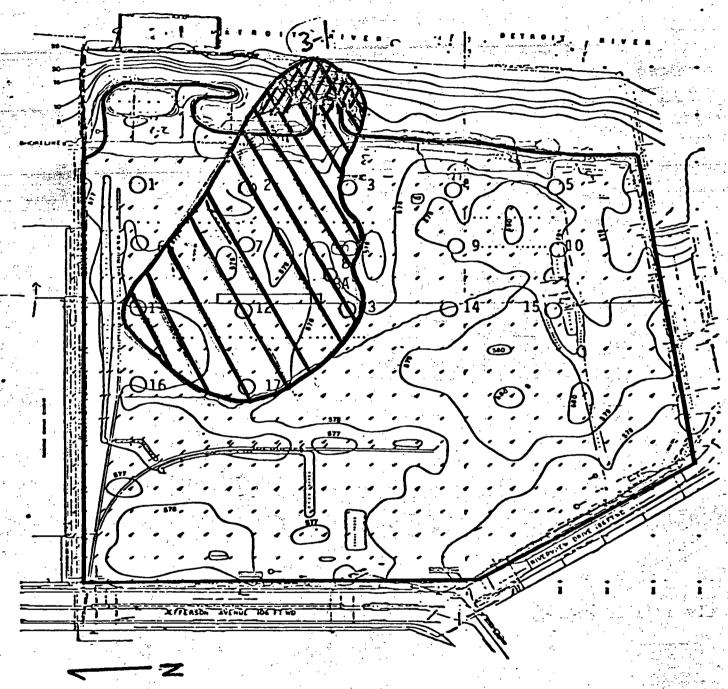
APPENDIX3: RESULTS OF TAT SAMPLING

Conc. of Hg>2mg/l IN Soil

Conc. of Hg>3.2 mg/kg IN SEDIMENT
